CONNECTICUT RIVER BASIN  
GRANBY, CONNECTICUT

MANITOOK LAKE DAM  
CT. 00672

PHASE I INSPECTION REPORT  
NATIONAL DAM INSPECTION PROGRAM

NOVEMBER 1979

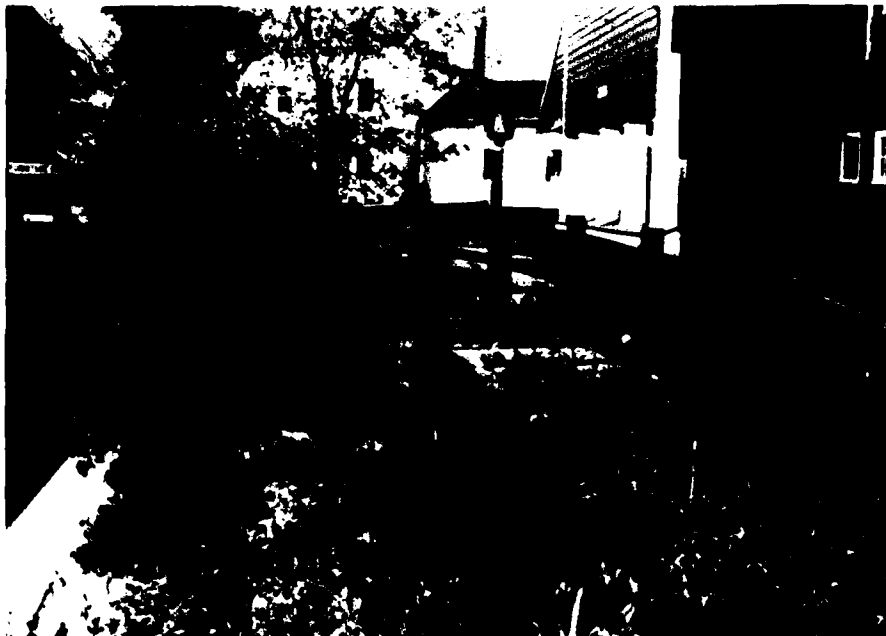
On the upstream face of the dam there is a concrete wall which connects the right side of the approach channel to an inlet structure. This inlet structure, controlled by a gate (see Photograph No. 2), once provided water to a turbine located in the basement of the building on the right side. Photograph No. 7 shows the turbine taken from the downstream side. The size of the conduit leading to the turbine could not be determined and the inlet invert elevation is unknown. The gate mechanism shows no signs of maintenance in recent years and is presently inoperative due to a broken gate stem. The concrete between the gate structure and the spillway shows some erosion and cavitation to a depth of about 6 in.

2. Inoperative outlet valve and 6 in. dia. tree on upstream face of dam.

- (1) Remove two small trees at the base of the dam just downstream of the spillway, and one tree on the upstream face of the dam.
- (2) Repoint missing mortar in joints of masonry wall and building foundations adjacent to the spillway.
- (3) Develop a formal surveillance and flood warning plan, including round-the-clock monitoring during period of heavy rainfall.
- (4) Institute procedures for an annual periodic technical inspection of the dam and its appurtenant structures.
